Manhole Inspection Summary

Manhole # S29AA_008MH

Insp Date: **11/26/07 12:43 PM**

Location Address: **REAR 1133 PENNSYLVANIA AVE**

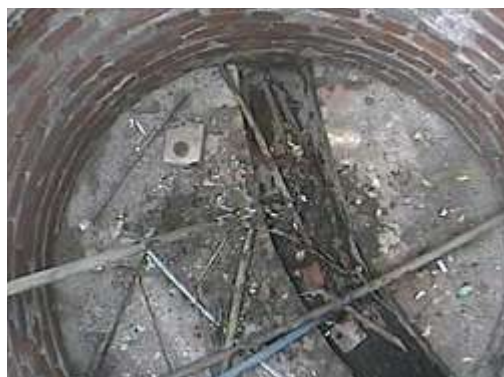
Defect 1

Condition: ☐ Sound ☐ Cracked ☐ Root Intrusion ☐ Deteriorated ☐ Leaks ☒ **Debris**

BENCH AND CHANNEL DEBRIS

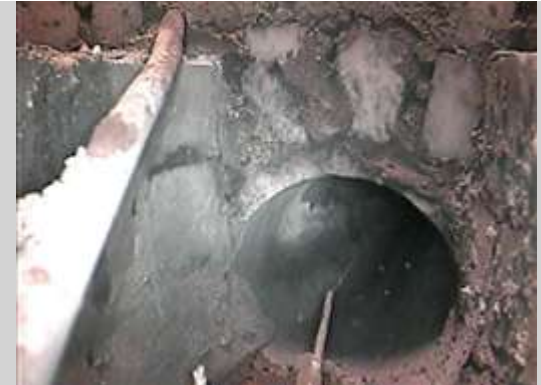
12 O'Clock Outflow

8 in. Circular Gravity Sewer
Pipe Out @ 12 O'Clock

Pipe Height: (in.) Direct
Pipe Material: **Clay** ☐ Pipe Lined
Invert Depth: **6.52** (ft.) Flow Characteristics: **None**
Deposits: ☐ None ☒ **Mud** ☐ Sludge ☐ Debris ☐ Grease
Silt Depth: **2** (in.) Deposits Extent: **Medium**
Infiltration: **None** Pipe Seal Cond: **Sound**

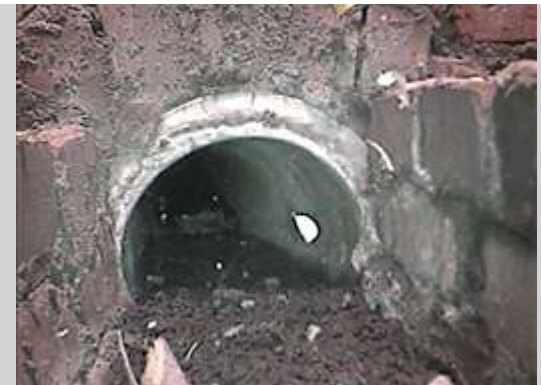
4 O'Clock Inflow

8 in. Circular Gravity Sewer
Pipe In @ 4 O'Clock

Pipe Height: (in.) Direct
Pipe Material: **Clay** ☐ Pipe Lined
Invert Depth: **6.12** (ft.) Flow Characteristics: **None**
Deposits: ☐ None ☒ **Mud** ☐ Sludge ☐ Debris ☐ Grease
Silt Depth: **3** (in.) Deposits Extent: **Medium**
Infiltration: **None** Pipe Seal Cond: **Sound**
